ASB-1044

Service Bulletin

Subject: TS-50S Mechanical Noise from Final Unit

Date: March 28, 1994

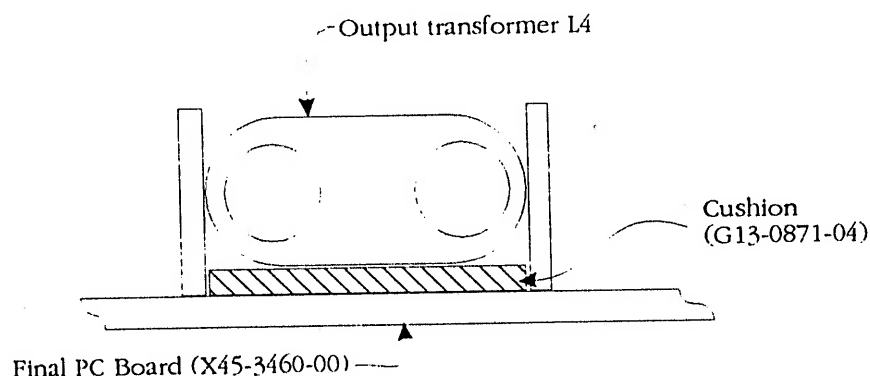
When the transceiver is subjected to vibration a mechanical noise can be heard from the output transformer area. This has led to concern by several consumers that something is loose or improperly installed.

In order to ease consumer concerns you should add a cushion under transformer L4 as shown in the accompanying diagram, and replace transformer L13 at the same time. This transformer has been fastened to the circuit board with high temperature adhesive, so use caution when removing it from the circuit board.
